AMERICAN SOCIETY  
OF  
CIVIL ENGINEERS

FOUNDATION PROBLEMS OF THE  
EKLUTNA PROJECT

by William R. Judd, A.M. ASCE

## FOUNDATION PROBLEMS OF THE EKLUTNA PROJECT

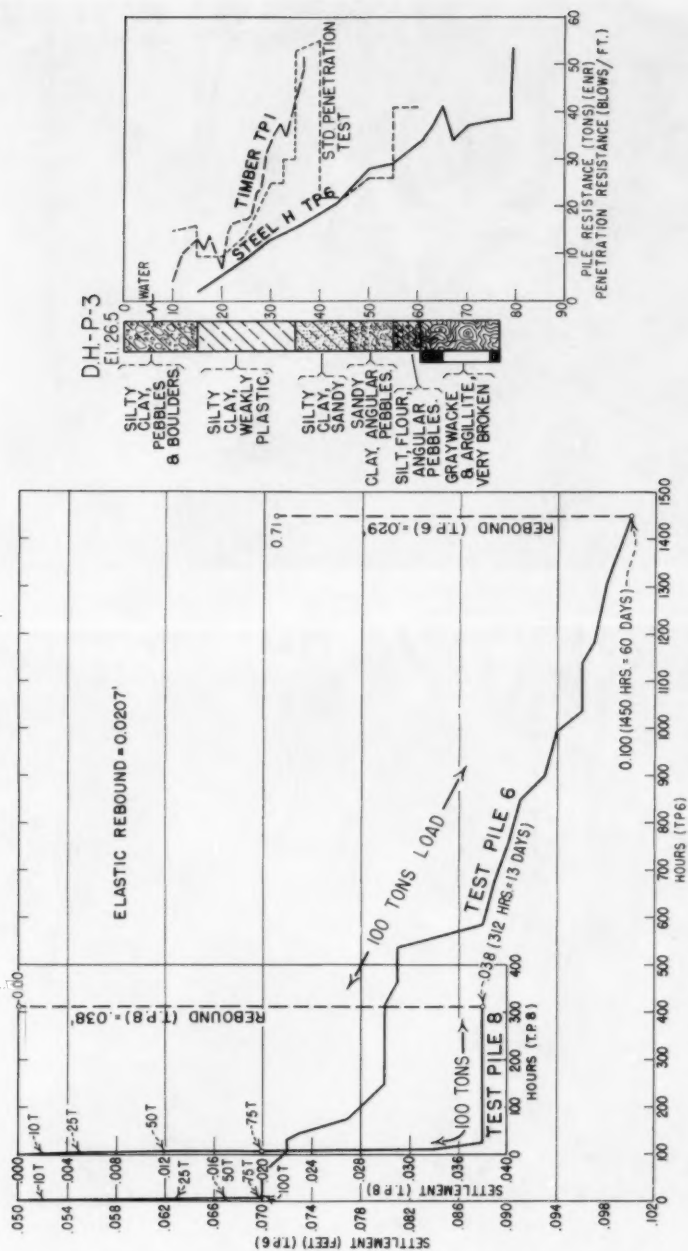
tests were instituted (Figure 9). The first few days gave satisfactory test readings, then after 17 days the piles started to settle, settlement then stopped for a few days, and then started again. This alternate settlement and rest continued over a 60-day period and the test was halted. The cause for this unusual test curve was not apparent because during driving every indication was that the pile was driven into bedrock. Although the rock was known to be badly fractured and faulted, this condition should not have caused the amount of settlement indicated in the test load readings. Therefore, an attempt was made to pull these 60- to 80-foot test piles. However, only portions of the piles could be retrieved. Apparently during driving the fishplates and rivets had sheared, the welds had broken, and, evidently, brooming had occurred.

Figure 9. Test Piles--Loading and Driving Results.

Fortunately, by this time, it was possible to secure 14-inch, 73-pound H-piles from the tunnel contractor. Besides vertical loads, the foundation design had to take into account (1) numerous moderate to heavy earthquakes known to occur in the area, and (2) the horizontal thrust from the high-head penstock. For these reasons, piles on a 1:4 batter, as well as vertical piles, were used. These piles were driven and test loaded both vertically and laterally. Both the driving and loading records (Figure 9) were satisfactory and thus the foundation design incorporated point-bearing 14-inch, 73-pound H-piles.

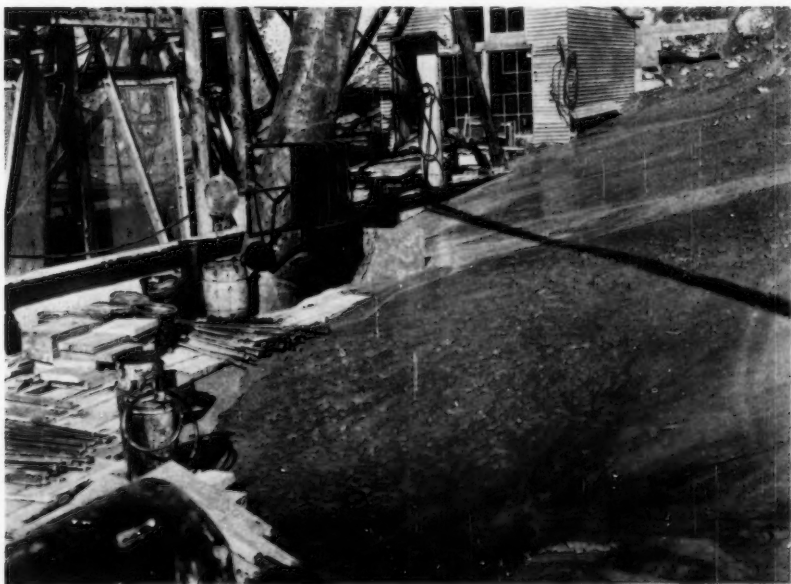
Figure 11. Mud Flows at Gate Shaft.

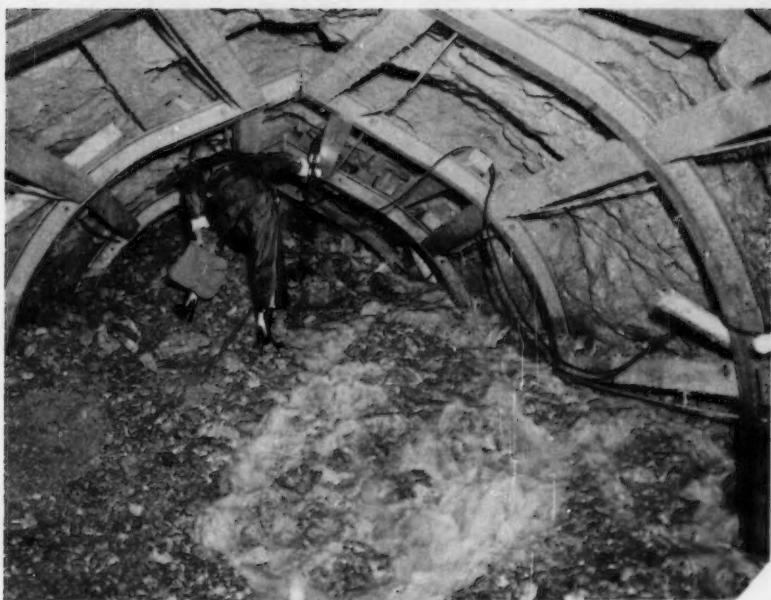
A dry 2-foot gouge zone had been noted at Station 208+70. This zone started to emit water in ever increasing amounts until by November 8, 10 feet caved in and the flow was 3,000 gallons per minute (Figure 12). Then, at 9 p.m., on November 9, an estimated 18,000 gallons per minute surged from the zone, and complete squeezing and overbreaks estimated at over 100 feet high occurred (Figure 14). Men and machines had previously been evacuated. The flow

Figure 12. Tunnel Cavein near Sta. 208+70.

During December, two 22-inch fan lines and appurtenant pumps were installed to handle the now diminishing water flow. Additional steel supports and solid lagging were placed where the tunnel had squeezed. By January 15, 1953, removal of the caved material was started, and by the end of the month, 2,000 cubic yards had been removed and the heading advanced into new ground. The water flow in the meantime diminished to 4,500 gallons per minute.

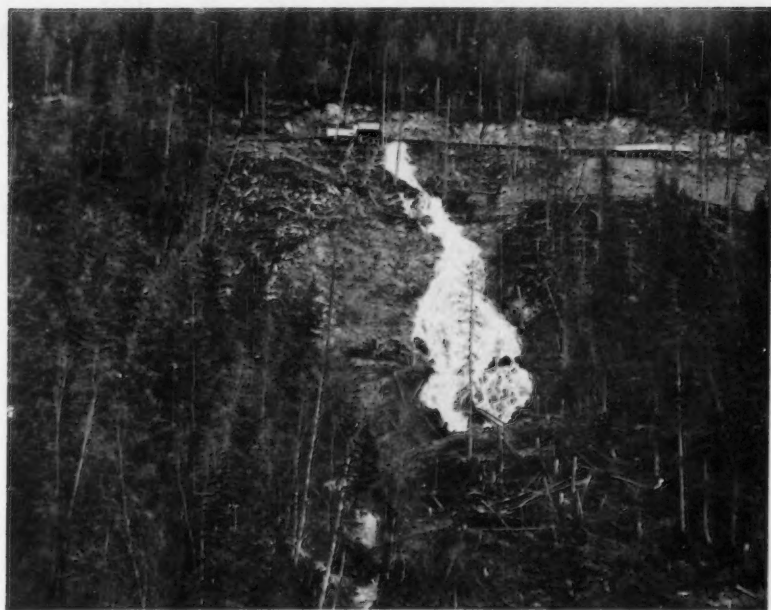
varied in intensity down to 7,800 gallons per minute, up to 13,000, and then down to 8,300 gallons per minute by December 5. This large flow could not be controlled when it first came out of the tunnel (Figure 13) and, thus, flooded the working area at the bottom of the hill. As a result, the sheet-piling around the penstock outlet collapsed (Figure 10), and the newly relocated road embankment was partially washed out.

Figure 13. 18,000 GPM Flow from Tunnel.
